STATIC ANALYSIS OF REAR SUSPENSION BEAM LOADING IN A POLISH COMBINE HARVESTER

This article shows the static analysis of rear suspension beam loading in a combine harvester manufactured by New Holland Bizon Sp. z o.o. The model of the examined machine with thresher rotor (Z110 model) was being manufactured until 2001, and further modifications of combine harvesters with the mentioned threshing system are being made so far [1]. The research conducted with the use of programs: Inventor 2017 for generating the digital model and Nastran In-CAD 2017 for simulation calculations. The aim of this article is to analyze and evaluate the accuracy of the combine harvester Bizon Z110 construction. The findings of the study suggest a possibility of stress accumulation in welded joints of construction. In result, solutions to the described problems were provided.

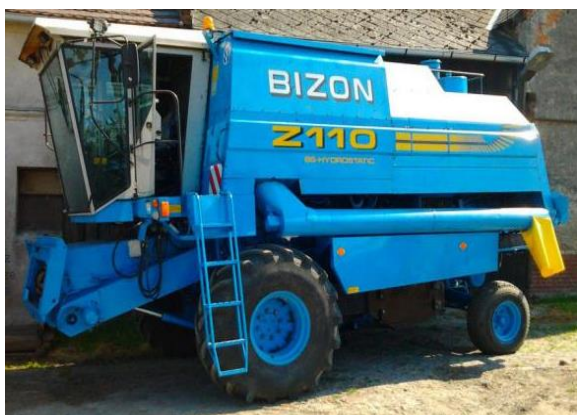
Fig. 1. The object of study - combine harvester New Holland Bizon BS Z110

On the grounds of literature premises and information from agricultural market, the object of study has been chosen, which is CNH Bizon model Z110 (Fig. 1). According to users of the machine, perpetual problems with cracking of the rear suspension clamp system are highly common. This failure occurs after usual exploitation of the combine harvester.

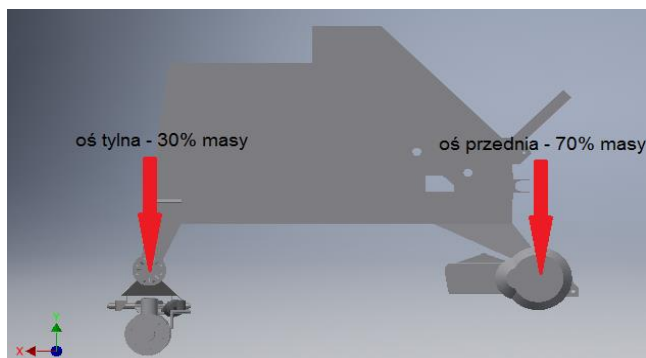
Fig. 5. Distribution of mass of the machine according to the manufacturer [5]

For obtaining a proper accuracy of calculations, actual values of forces affecting the object were determined. In this situation forces determined by the combine harvester mass are the load of analyzed joints. According to the manufacturer, the mass distribution is: 70% on the front axle and 30% on the rear axle, considering the variant with a straw crusher and aggregated with auger header, which is presented on Figure 5. The combine harvester mass with empty grain tank equals to 9940 kg, the mass of the auger header is 1420 kg, and the grain tank capacity is 5000 dm³ which corresponds to the mass of 4000 kg in case of the heaviest possible grain which is pea. It is because of the fact that 1 dm³ of grain has its average mass of 0.8 kg [3].

On the basis of evaluated masses, it was determined that their total amount equals to 11360 kg for an empty grain tank and 15360 kg for a full grain tank. This was the ground for estimating the mass (30%) which loads the rear suspension: 3408 kg for an empty grain tank and 4608 kg for a full grain tank. Masses values are presented on Table 1. Forces which load the digital model of the rear beam were calcu-
