LOCATION OF THE ADHESIVE PATH IN JOINTS OF THIN CAR BODY SHEETS

Bonding technology is one of the oldest technologies of joining car body elements. Bonding steel in real industrial conditions may cause various incompatibilities in the joints area. The main ones consist in the lack of adhesion and no adhesive in the area of the joints. Currently there are destructive methods of controlling adhesive joints that require destruction of the joint. Destruction of joint generates significant costs especially when assessing joints in commercial vehicles. However assessment on vehicles being repaired or operated is not possible, because it causes total destruction of the joint. As a part of the work it was decided to check whether the ultrasound echo technique would enable locating these areas in the vehicle body in which there is no adhesives or lack of adhesion occurs - not only on prepared samples but also on the element - the door of a currently produced car vehicle. The ultrasonic measurements were verified during the destructive control of adhesive joint in the doors of a motor vehicle. The tests confirmed that the proposed measures of quality enable the location of the adhesive path

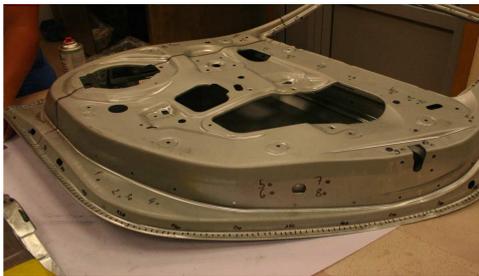
Fig. 4. Car doors subject to ultrasonic inspection in the scope of adhesive in the rim

After experimental tests the presence of adhesive in the edge of the car door was assessed (Fig. 4).
