ASSESSMENT OF THE CONDITION OF THE COATINGS AFTER THE TESTS IN A SALT SPRAY CHAMBER

Summary

Adhesive coatings in the form of layers are widely used in the protection of machines and equipment against corrosion. The article presents the research of four prepared areas which were subject to the influence of brine in the salt spray chamber. Powder paint was applied to one of the areas, another was covered with alkyd paint, another - with paint from spray can, and one of the areas was not protected against corrosion. The samples were exposed in a salt spray chamber. Changes occurring in the layers of individual coatings were registered at predetermined time intervals which were set in accordance with the standard. In addition, coating thickness measurements were made before and after samples exposure to brine. Based on the research, it was found that the first defects of powder coated coatings appeared only after 25 hours of brine influence, in contrast to the other areas where it occurred definitely early because after only 2 hours after starting the experiment.

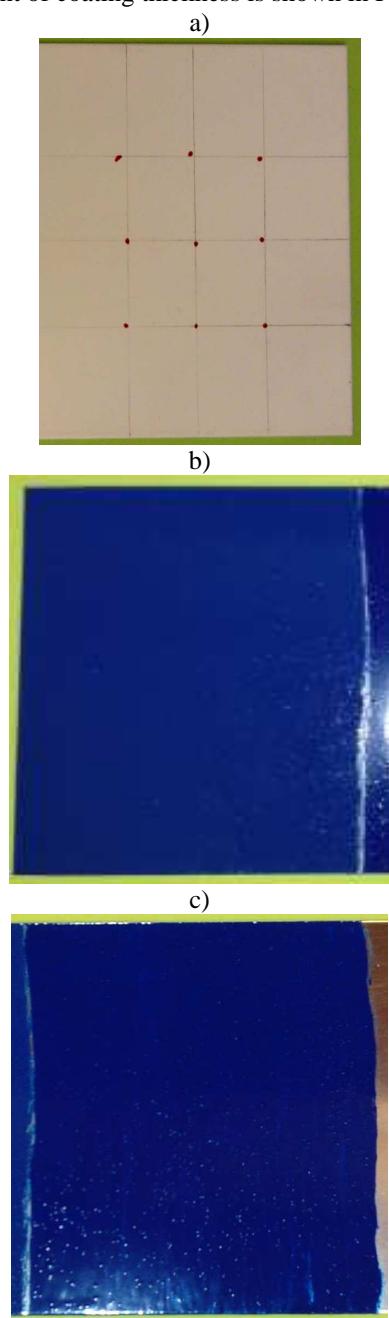
kyd coating and a spray coating were applied. In addition, one of the areas was only degreased for which no corrosion protection was applied. The view of prepared samples with a template of measuring points which were used in the measurement of coating thickness is shown in Fig. 1.

Fig. 1. Aluminum samples used during the studies; a) spray coating, b) paint in spray can, c) alkyd paint

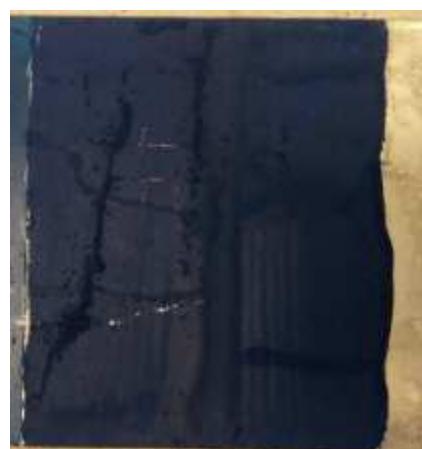
Analysis of the thickness of the sample painted with alkyd paint has shown that the coating was applied evenly. The minimum coating thickness is 29.4 μm while the maximum 31.2 μm . The tests in the salt spray chamber caused defects on the surface of the sample. The coating has been wrinkled under the influence of sodium chloride mixture. This was evident already after the first test period in the salt spray chamber (Fig. 7) and deepened with the effect of sodium chloride (Fig. 8).

Fig. 7. Alkyd coating after 2 hours of exposure to sodium chloride
Rys. 7. Powłoka alkidowa po 2 godzinach oddziaływania chlorku sodu

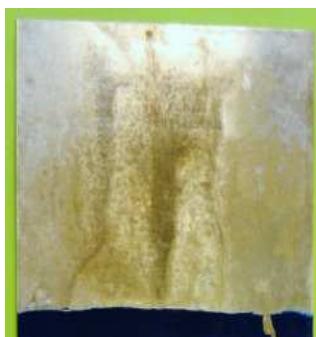
In order to observe the reaction of aluminum to the sodium chloride mixture in the sample painted with aerosol paint and alkyd paint the zone was left without coating with varnish. Surface corrosion occurred on the surface of the sample. The view of the area without corrosion protection after 25 hours in the salt mist chamber is shown in Fig. 9.

Fig. 9. The area without coating after 25 hours of exposure to sodium chloride
