THE COMPARISON OF EFFECTS OF THERMAL SPRAYING EUTALLOY 10112 AND LASER ALLOYING WITH SILICON NITRIDE OF CAST IRON OUTMOST DISK COULTER

Key words: thermal spraying, laser alloying, outmost disk coulters, abrasive wear

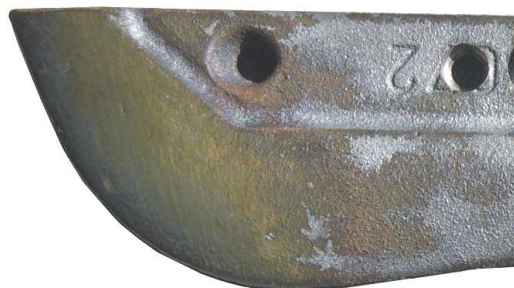
Fig. 3. The side surface view and the edge of outmost disk coulters foot without any additional modification after the wear test

It was observed that, after wear test surfaces of the sides of all outmost disk coulters cooperating with the ground soil were wiping, and the blade edges have been rounded. As a result of intense friction outmost disk coulters without additional modification have been smoothed out and gained polished. The side surfaces could be seen also small grooves in accordance with the direction of movement of abrasive particles. The side surface view and the edge outmost disk coulters without any additional modification after the wear test was shown in fig. 3.

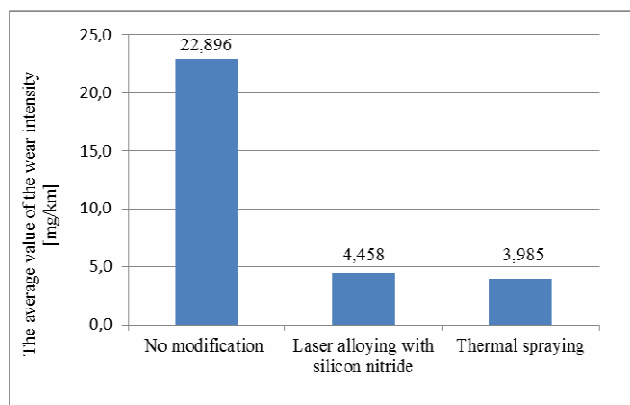
Fig. 5. The values of the wear intensity of outmost disk coulters [$\mu\text{g}/\text{km}$]

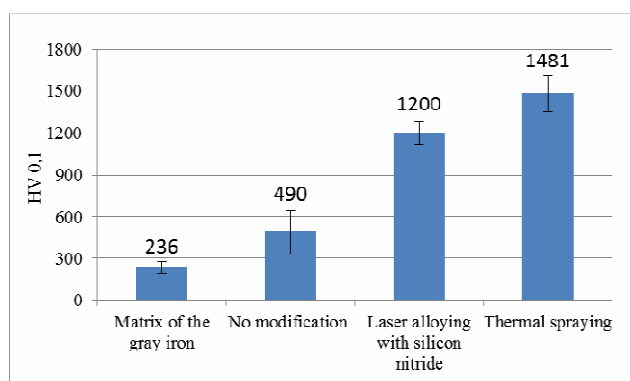
Fig. 6. The average hardness of the edge of the outmost disk coulters with and without additional surface treatments and the average hardness of the matrix of gray iron

The surface layer after laser alloying with silicon nitride was characterized by lower value of average hardness – approx. 1200 HV0.1. Taking into account that white cast iron (occurring at the edge of outmost disk coulters without any additional surface treatment) is characterized by average hardness of about 500 HV0.1 2,5-times hardness increased could be stated after performed surface treatments. In comparison to the matrix of gray iron (230HV1.0) 5-times increased of hardness occurred in surface layer after performed surface treatments (fig. 6).
